WILLIAM PATERSON UNIVERSITY

INVIGORATING THE CORE THE ACADEMIC ZONE MASTER PLAN

27 JUNE 2012

Perkins Eastman

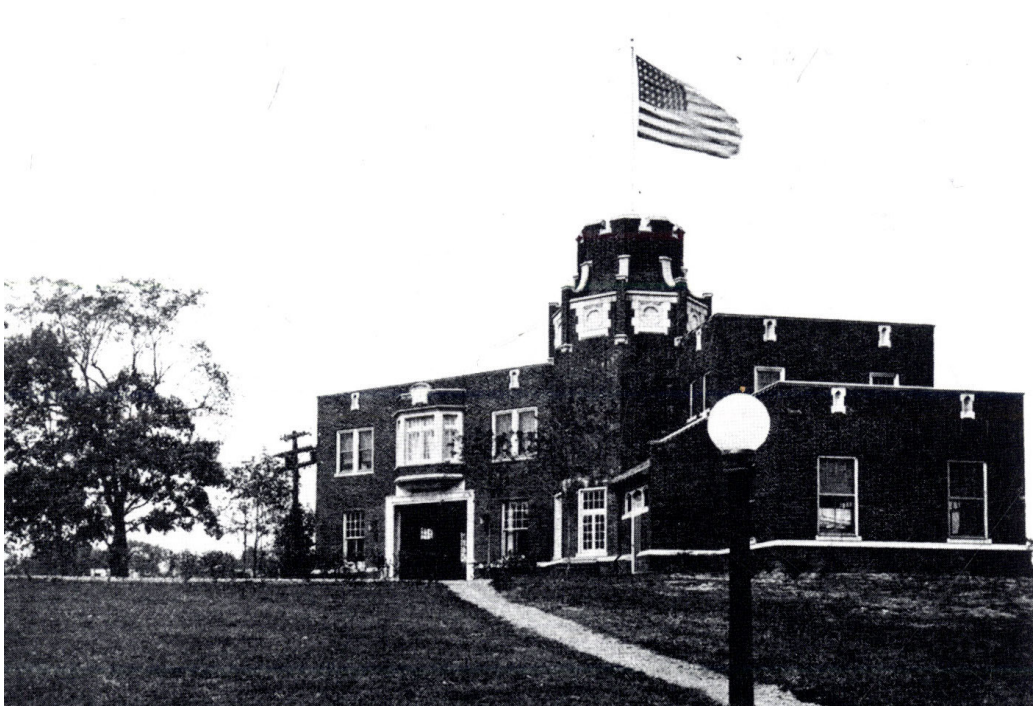
Graphic 3.8
Coach House

From the perspective of alumnae, the Coach House is one of the most appreciated buildings on campus. It is one of the last remaining vestiges of the Hobart Estate, believed to have been constructed around 1919 and originally serving as a storage garage and laundry facility for the Hobart family. This brick masonry building is vaguely neo-gothic in style (referencing the Hobart Manor), and its original façade is distinguished by a castle-like turret. Alumnae and faculty alike seem to have a strong affinity for the building as it was once used as a snack bar and dining pavilion and was the center of the University's social scene early in its development. The building is probably also appreciated as one of

the few buildings on campus that reference a pre-Modernism heritage. It is unclear if the University's current students have a similar affinity for the Coach House as the building is much altered from its mid-century condition and is presently in poor repair.

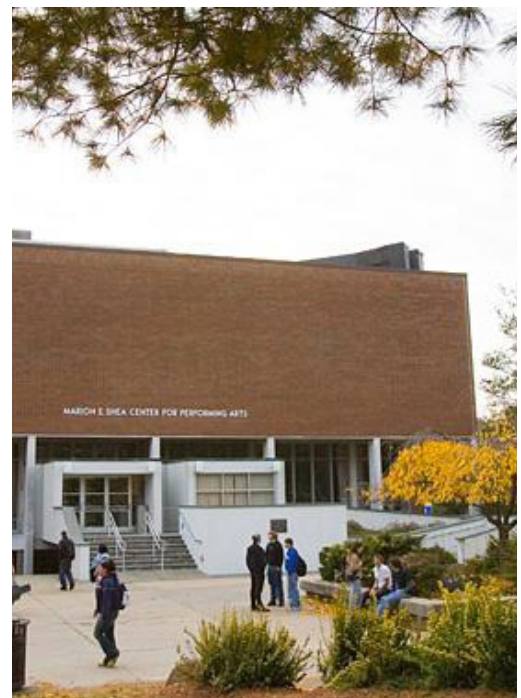
Graphic 3.10
Shea Center - Circa 2010

The Shea Center for Performing Arts, also from 1968, is clearly a building in the Modernist style. Yet it is a building without drama or ornamentation beyond its strong geometries (which are only evident from aircraft or aerial photography). Shea's architectural style may most closely resemble a sub-set of Modernism called Functionalism, popular in Europe in the 60s and characterized by straight angles, flat roofs and a roughness that purposefully eschews ornamentation of any type.

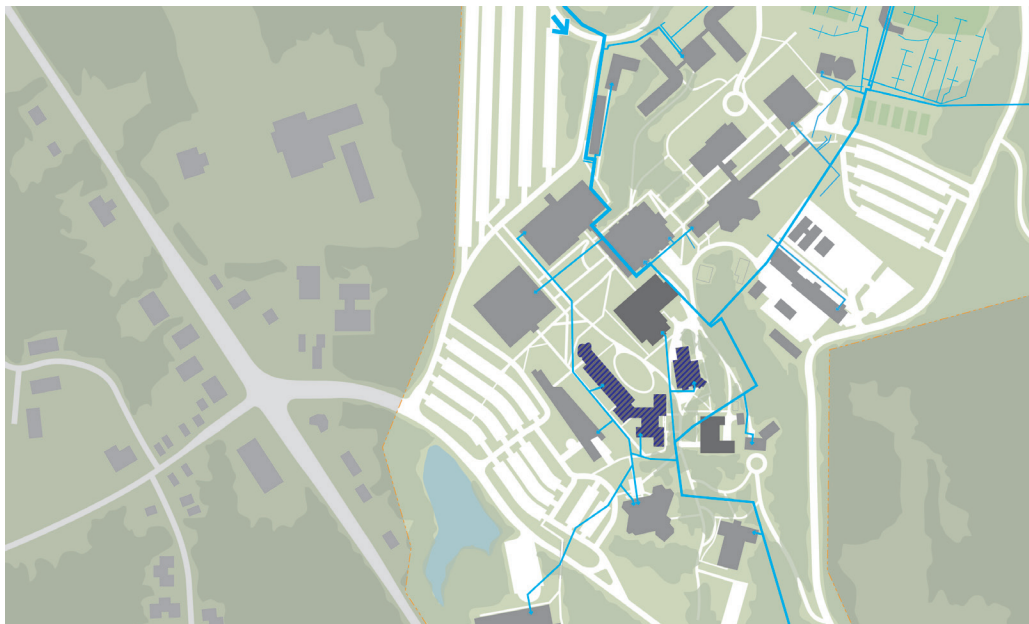
Graphic 5.1
Existing Water and Steam
Infrastructure

The connection between Hunziker Wing and Coach House (located under Speert Garden) has a significant leak and can require one full-time staff person in Hunziker Wing to monitor the system when it is in use. The University has explored taking Coach House off this steam system, but has tabled any decision with the anticipation that Coach House's mechanical systems will either be replaced or taken fully off-line over the next decade.

It is University policy to eventually decouple the Coach House from Hunziker Wing's steam system, and for the University to not have any multi-building mechanical systems. This

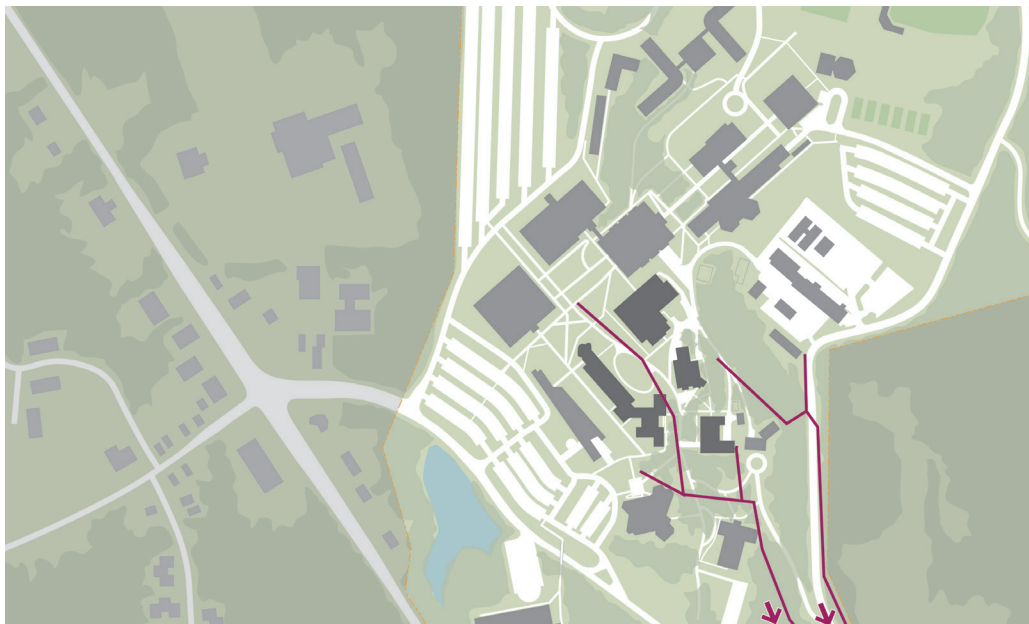
Graphic 5.3
Existing Sanitary Sewer
Infrastructure
— Sanitary Sewer

The campus sanitary sewer system is a gravity collection system that connects to the Wayne Township sewer main line along Pompton Road. The age, condition and capacities of much of this system (including service from Wayne Township’s Department of Public Works) are unknown. The Academic Zone’s sanitary sewer services the entire campus, including University Commons, the Library and Atrium. There are no known combined sewer overflow [CSO] outlets.

The campus storm sewer system is a gravity collection system. It connects to the main storm lines and spills into a stream on the south side of the campus, beyond the built-up areas. Conditions and capacities of much of this system are unknown.

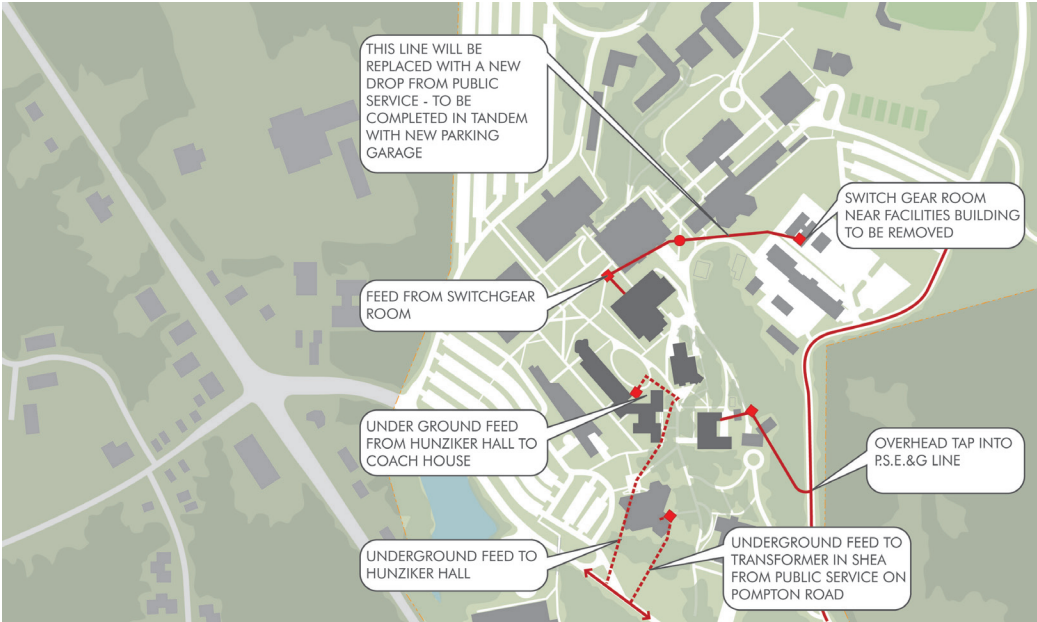
- Electrical - Overhead ———
- Electrical - Underground - - - -
- Switch Gear Room ■

The University's electric utility is Public Service Electric and Gas [PSE&G] with the main electrical drops off of PSE&G's lines on Pompton Road and East Road. A secondary distribution system exists on campus, though at the time of the Academic Zone study the University is in the middle of planning for the reorganization and upgrade/replacement of much of the electrical infrastructure.

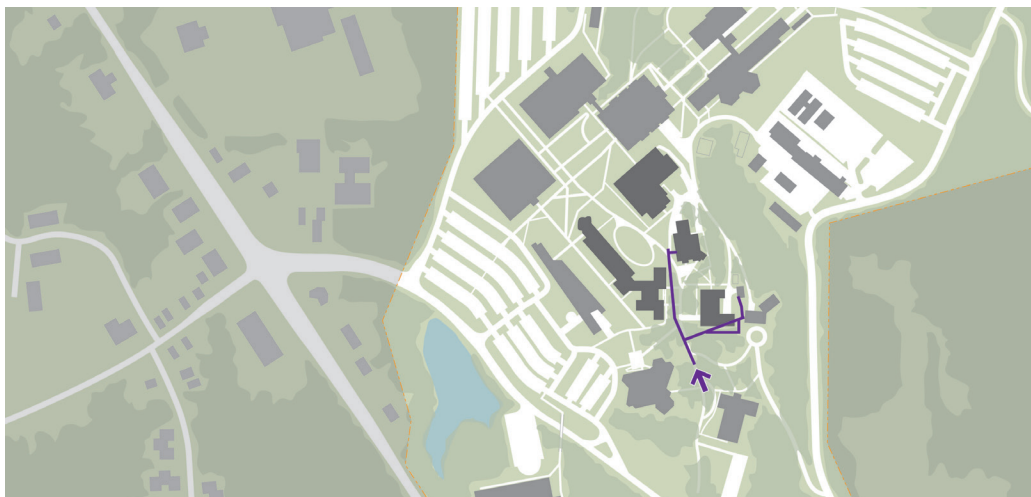
Graphic 5.5
Existing Natural Gas Infrastructure
— Gas

Natural gas service to the Academic Zone is from PSE&G’s Pompton Road line, and comes up from between Morrison Hall and the Shea Center. This line also services the rest of the campus. While the age, condition and capacities of much of this system (including service from PSE&G) are unknown, this system was the subject of significant investment when the University abandoned the central steam system.

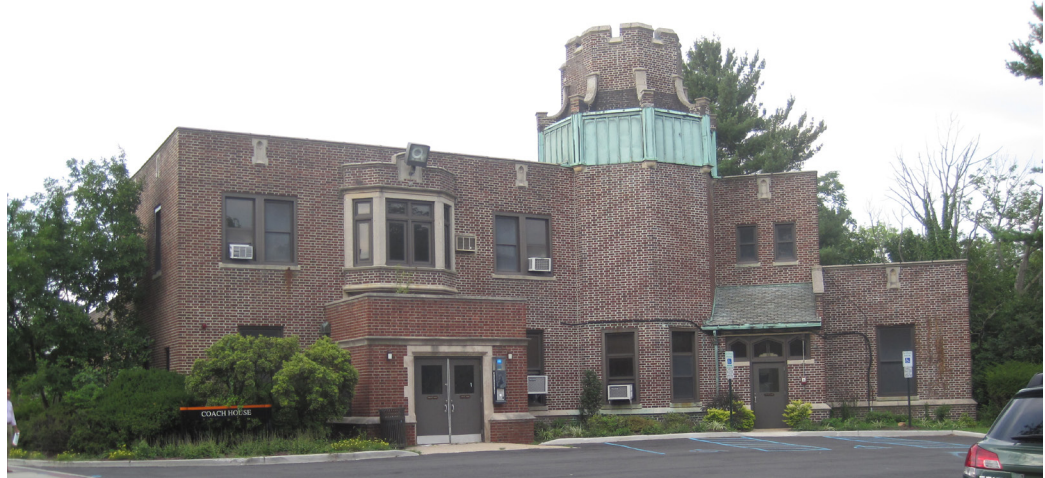
Graphic 5.6
Coach House

The Coach House's exterior, interior and building systems are generally in very poor condition and require costly upgrades in the near-term. Additionally, the multiple renovations and additions to the building have made the building a mess with multiple structural systems, floor levels and mechanical systems that do not fully coordinate.

- Building Exterior
 - Replace the roof of this building immediately.
- Health, Safety & Access
 - Replace the stairs to the second level as they are highly unsafe in the event of an emergency.
- Mechanical System
 - Replace rooftop units with variable air volume type units or DX.
 - Install new ductwork distribution with VAV boxes for both floors.
- Plumbing System
 - Replace all asbestos insulation on existing piping and install new asbestos-free insulation.
 - Install one three-inch RPZ on the existing domestic water service.

- Building Exterior
 - Replace all windows to improve thermal efficiency.
 - Replace exterior doors and frames.
- Building Interior
 - Renovate interior walls. Conditions vary, but interior walls are generally in poor condition with damaged and degraded finishes. The upper level is aged and in extremely poor condition.

- Replace interior doors and frames throughout.
- Mechanical System
 - Steam line shall be capped and hot water provided from Hunziker Wing plant for new hot water radiators.

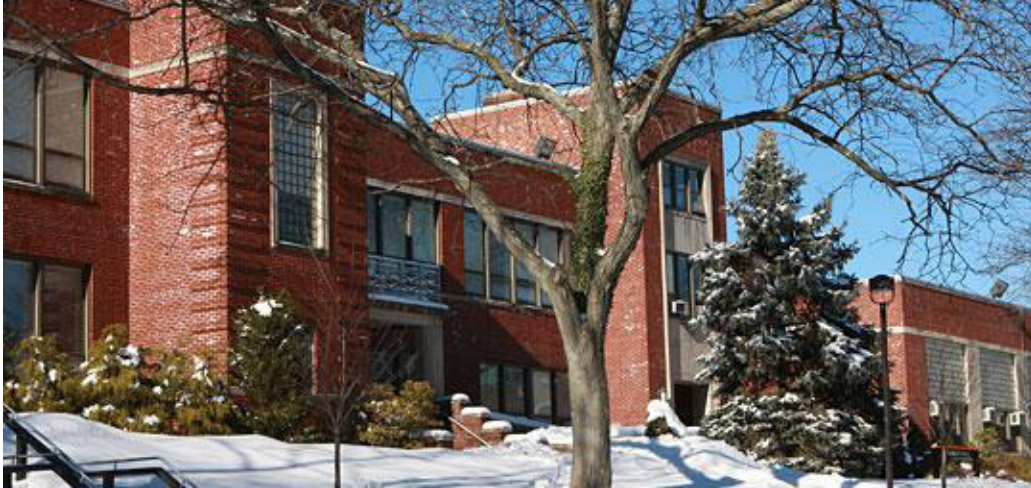
Graphic 5.7
Hunziker Hall

Hunziker Hall's exterior, interior and building systems are generally in poor condition and require significant upgrades in the near to intermediate terms.

Near-Term Repairs (0–2 Years)

- Mechanical System
 - Refurbish or replace existing units in kind. Unit ventilators are a good option for providing cooling and heating in classrooms in retrofit applications where ductwork distribution is impractical. Attention needs to be given to reducing unit noise, which can impede instruction.
- Plumbing System
 - Replace the existing duplex sump pumps.
 - Replace the existing duplex ejector pumps.
 - Replace all asbestos insulation on existing piping and install new asbestos-free insulation.
 - Install one four-inch RPZ on the existing domestic water incoming service.
- IT/Telecommunication System
 - Defer the installation of fiber and APC Pigtails to Hunziker Hall for CATV (item E-006-08 under Deferred Maintenance List). The installation should occur

Intermediate-Term Repairs (2–5 Years)

- Building Exterior
 - Repair the foundation of this building as it is in poor condition; leaking and flooding has occurred in the basement level and there are visible signs of water damage.

- Replace the roof of this building within the next five years as it is nearing the end of its useful life.
 - Replace all windows to improve thermal efficiency.

- Replace exterior stairwell doors and frames throughout.
- Building Interior
 - Replace interior stairwell doors throughout.
- Mechanical System
 - Replace all existing window AC units with either unit ventilators or centralized DX split systems.

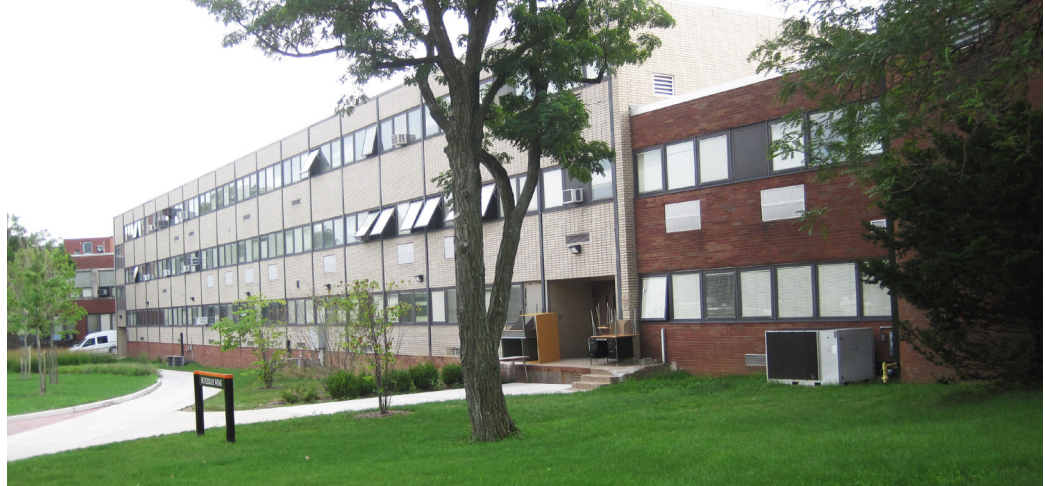
Graphic 5.8
Hunziker Hall Wing

Hunziker Hall Wing's exterior, interior and building systems are generally in fair to poor condition and require significant upgrades in the near to intermediate terms. This building is also the tele/data hub for the campus.

Near-Term Repairs (0–2 Years)

- Mechanical System
 - Refer to Hunziker Hall
- Electrical System
 - Refer to Hunziker Hall
- Plumbing System
 - Replace all asbestos insulation on existing piping and install new asbestos-free insulation.
 - Install one four-inch RPZ on the existing domestic water service.
 - Install one four-inch DDCV on the existing fire water service.
- IT/Telecommunication System
 - Server Room - Main Point of Entry and Campus Riser - Ground Floor
 - Remove abandoned cables and obsolete equipment.
 - Install a telecommunications grounding infrastructure.

Intermediate-Term Repairs (2–5 Years)

- Building Exterior
 - Replace all windows to improve thermal efficiency.
 - Replace exterior stairwell doors and frames throughout.
- Building Interior
 - Replace interior stairwell doors throughout.

- Mechanical System
 - Refer to Hunziker Hall
- Electrical System
 - Refer to Hunziker Hall
- Plumbing System
 - Replace the hot water 80-gallon storage residential type heater with a new instantaneous gas fired heater.

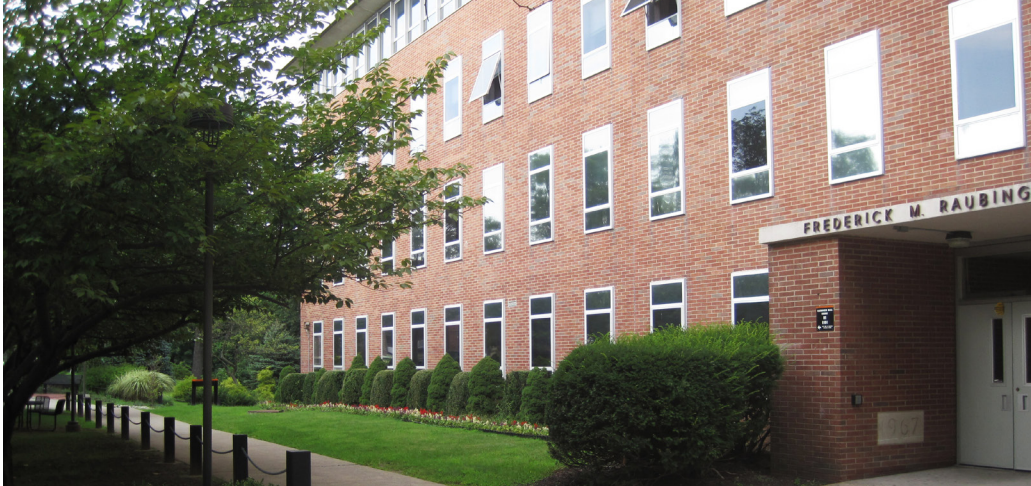
Graphic 5.10
Raubinger Hall

Raubinger Hall's exterior, interior and building systems are generally in fair condition and require modest upgrades in the near to intermediate terms.

Near-Term Repairs (0–2 Years)

- Mechanical System
 - All air handling units in the basement MER shall be completely replaced with VAV type units. All return fans shall be replaced in kind.
 - Insulation shall be reapplied on the piping inside MER.
 - Piping, fittings and valves that have been damaged or rusted shall be replaced.
- Plumbing System
 - Replace all asbestos insulation on existing piping and install new asbestos-free insulation.
 - Install one four-inch RPZ on the existing domestic water service.
 - Install one four-inch DDCV on the fire water service.
- IT/Telecommunication System
 - Install proper grounding for IDF room racks.
 - Install conduit sleeves for cables passing through walls. Fire-proof sleeve if wall is rated.

Intermediate-Term Repairs (2–5 Years)

- Building Exterior
 - Replace all windows to improve thermal efficiency.
 - Replace exterior stairwell doors and frames throughout.
- Building Interior
 - Replace interior stairwell doors throughout.

- Mechanical System
 - Replace the air handling units, fans and existing ductwork as they have well exceeded their useful service life.
 - Install new ductwork distribution from basement to the floors currently served by respective units.

- Electrical System
 - The main building service is in excess of 50 years and is challenging for the campus electricians to find replacement parts. While the current electric service adequately serves the present loads of the building, any forthcoming renovations or program changes should include a replacement of the main electric service and associated branch circuit panels.

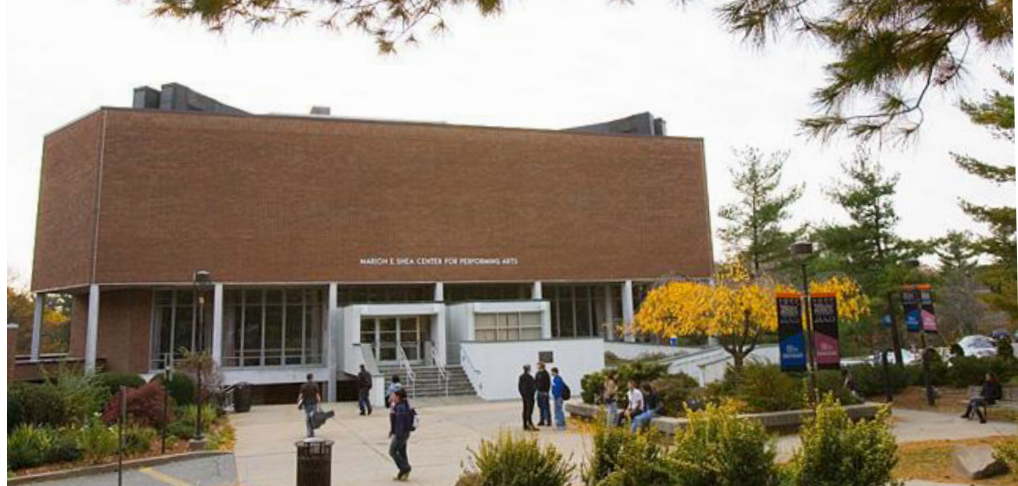
Graphic 5.12
Shea Center for Performing Arts

Shea's exterior, interior and building systems are generally in poor to fair condition and require some significant upgrades in the near to intermediate terms. This includes significant accessibility challenges, multiple floor level elevations and awkward room and corridor arrangements in the lower level of the building.

Near-Term Repairs (0–2 Years)

- Mechanical System
 - Replace insulation on the piping inside MER.
 - Replace piping, fittings and valves that have been damaged or rusted.
 - Replace chilled water pumps in kind.
- Plumbing System
 - Replace all asbestos insulation on existing piping and install new asbestos-free insulation.
 - Install one three-inch RPZ should be installed on the domestic water service.
- IT/Telecommunication System
 - Defer the installation of fiber and APC Pigtailed to Hunziker Hall for CATV (item E-007-09 under Deferred Maintenance List). The installation should occur when the new IDF rooms are built

Intermediate-Term Repairs (2–5 Years)

- Building Exterior
 - Replace all windows to improve thermal efficiency.
 - Replace exterior stairwell doors and frames throughout.
- Building Interior
 - Replace interior stairwell doors throughout.

- Mechanical System
 - New ductwork distribution shall be provided as well from basement to the floors currently served by respective units.
 - Replace the air handling units and existing ductwork as they have exceeded their useful service life. Air handling units in the basement MER shall be replaced with VAV type units.

- Replace the BMS system with a DDC type.
- Electrical System
 - The branch circuit panels which serve the rest of the buildings (non performance area classrooms, corridors, etc.) are antiquated and, because of their age, are challenging to maintain. While they adequately serve the present load, if any renovations are undertaken to these areas the branch circuit panels should be replaced.

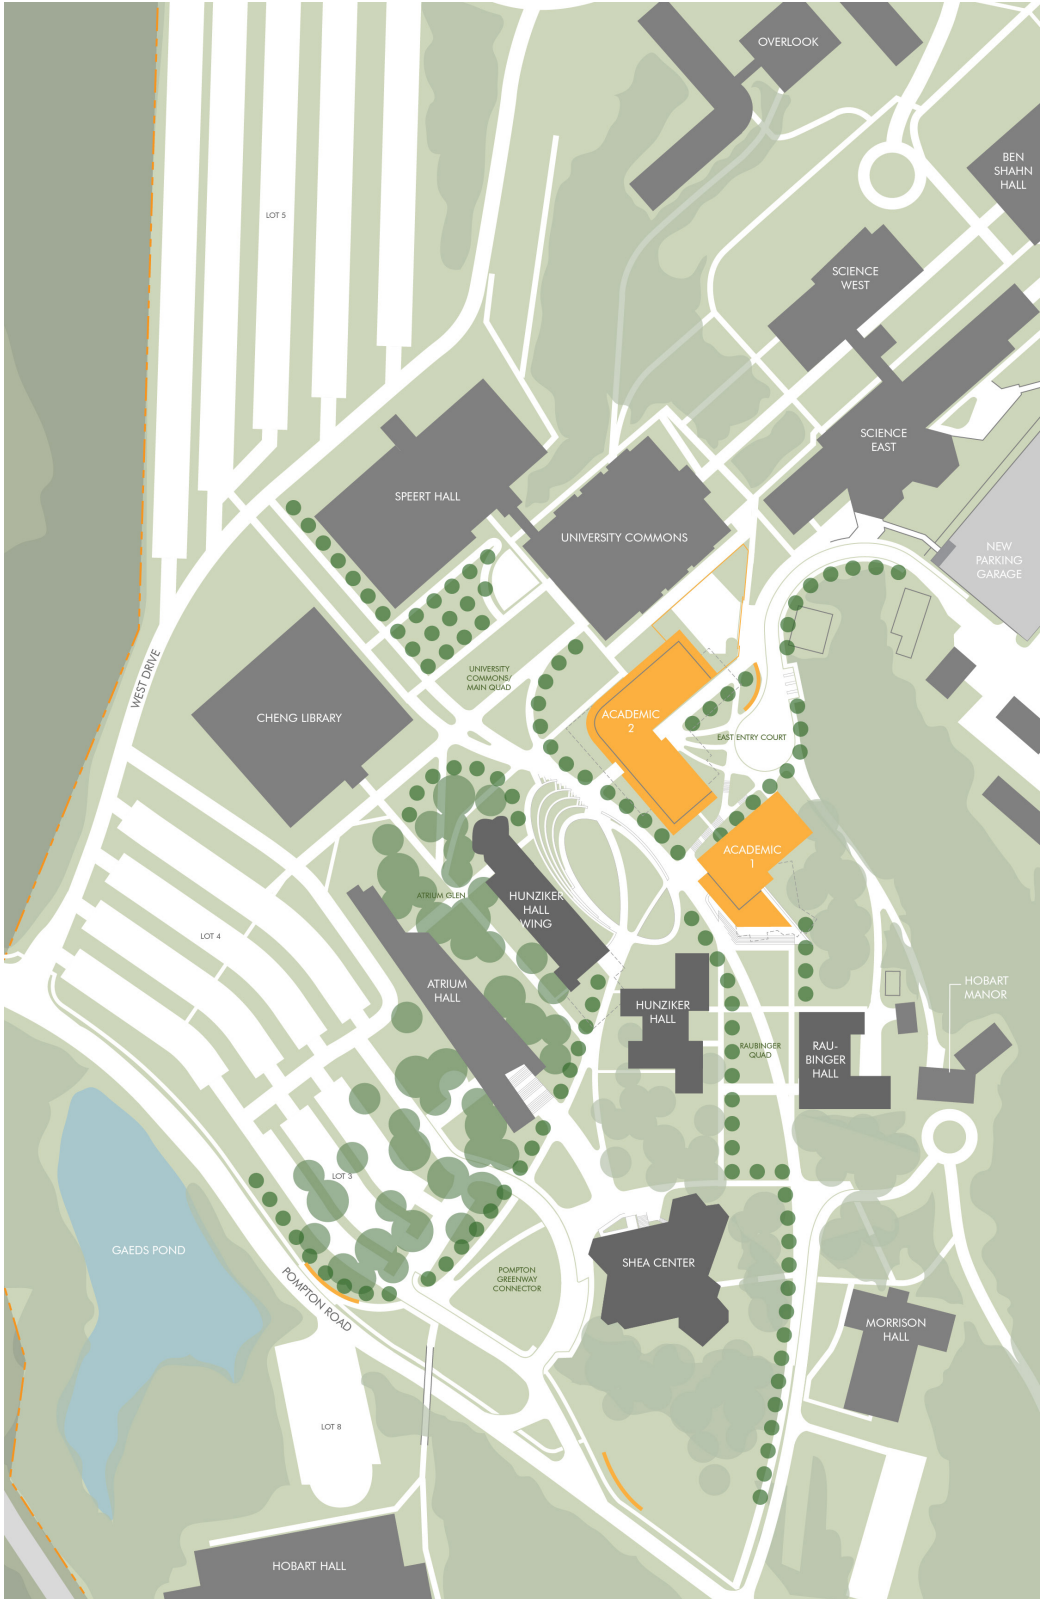
Graphic 9.1
Academic Zone Master Plan

The following section outlines recommendations for the existing buildings, proposals for two new buildings and a conceptual organization for open space in the Academic Zone. These recommendations were the result of an iterative process that examined several alternatives. Drivers of the final plan include:
